magicolor[®] 330

Service Manual

November 2000
1750049-001B

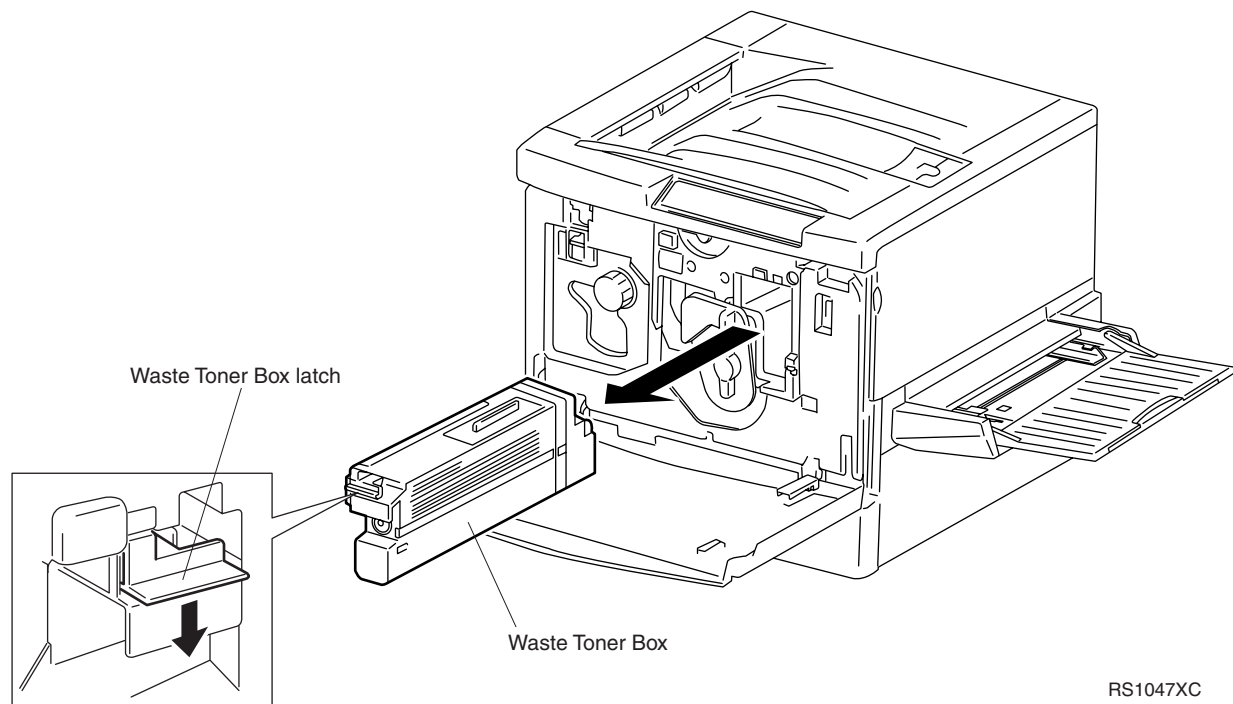
RRP 9.49 Waste Toner Box (PL6.1.12)

1. Open the Front Cover.
2. Slide the Waste Toner Box into the Toner Box cavity.
3. Push in on the Waste Toner Box until it latches into place.
4. Raise the IBT Tension Lever.
5. Close the Front Cover.

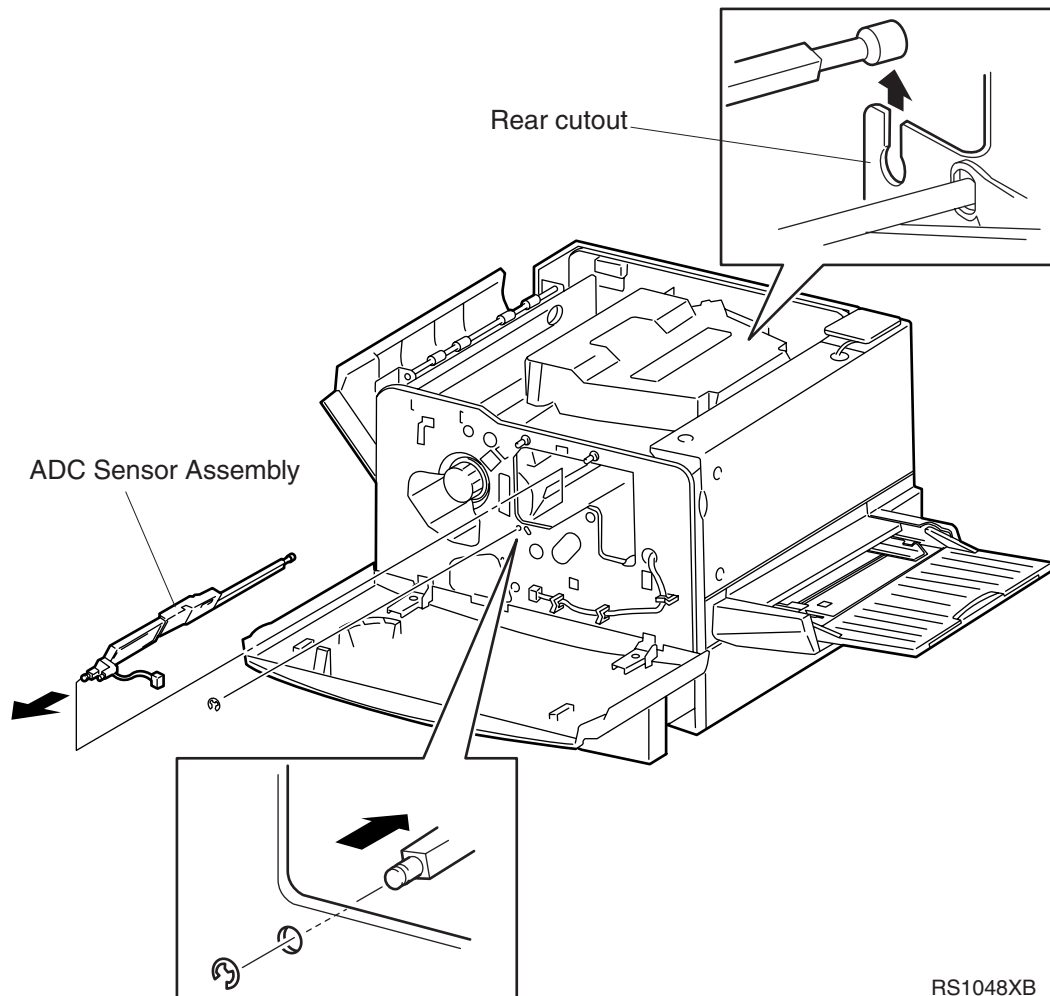
RRP 9.50 ADC Sensor Assembly (PL6.1.20)

1. Slide the shaft end of the ADC Sensor Assembly into the slot at the rear of the printer cavity.
2. Push the shaft far enough to the rear for you to slide the front of the shaft into the hole in the front of the printer frame and the positioning tab into the slot next to the hole.
3. Slide the rear of the shaft down into the rear slot.
4. Insert P/J 81 through the grommet hole.
5. Use an E ring to secure the front of the ADC Sensor Assembly to the front of the printer frame.
6. Reconnect P/J 81.
7. Reinstall the Inner Cover Assembly (RRP 9.2).
8. Reinstall the Xerographic Cartridge (RRP 9.48).

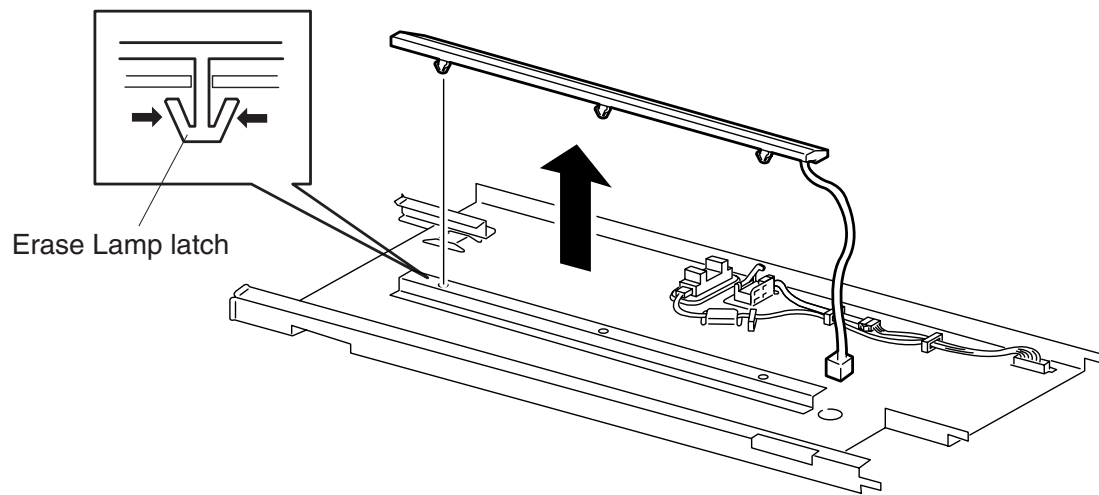
RRP 9.51 Erase Lamp Assembly (PL6.1.30)

1. Route the Erase Lamp wire through the hole in the top of the printer frame.
2. Position the Erase Lamp against the XL Rail Assembly so the three latches on the Lamp line up with the three holes in the Rail Assembly.
3. Press the Erase Lamp Assembly against the Rail Assembly so the three latches snap into place.
4. Reinstall the XP Rail Assembly (RRP 9.52).

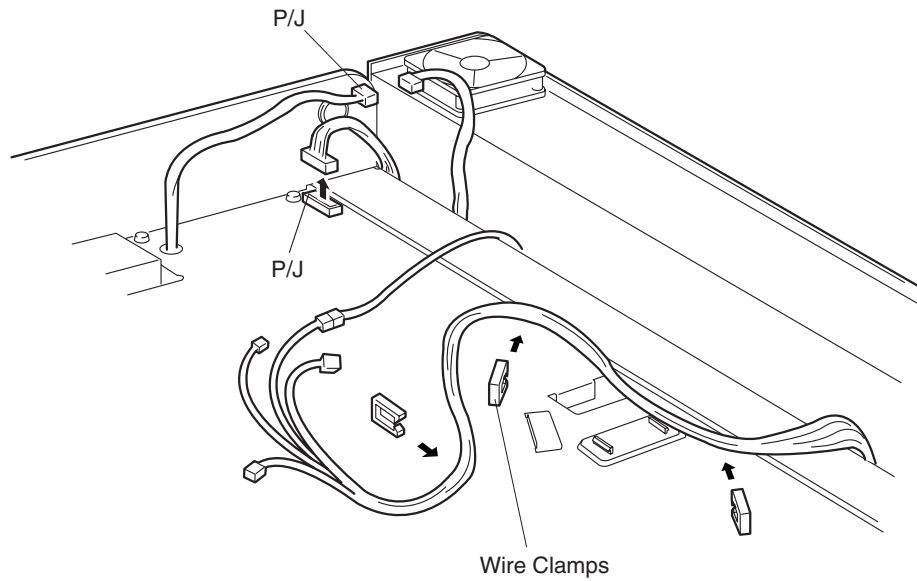
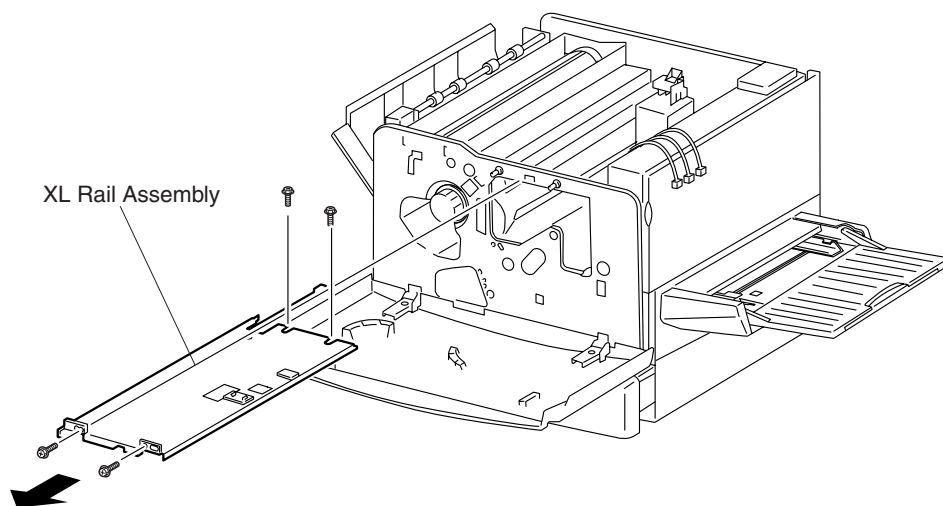
RRP 9.52 XL Rail Assembly (PL6.1.40)

1. Move all of the wire harnesses out of the way.
2. Lower the XL Rail Assembly drop through the top of the printer frame.
3. Insert the three tabs that are located at the rear of the XL Rail Assembly into the three holes at the rear of the printer frame.
4. Position the front lip of the XL Rail Assembly so it is on the outside front of the printer frame.
5. Line up the four screw holes in the XL Rail Assembly with the four screw holes in the printer frame.
6. Use four screws to secure the Assembly to the printer frame.
7. Reconnect P/J 86 to the Erase Lamp.
8. Reconnect P/J 89 to the Toner Box Sensor.
9. Reconnect P/J 83 to the Waste Toner Sensor.
10. Secure P/J 83 and P/J 86 under the wire clamps.
11. Reinstall the ROS Assembly (RRP 9.47).
12. Reinstall the Xerographic Cartridge (RRP 9.48).

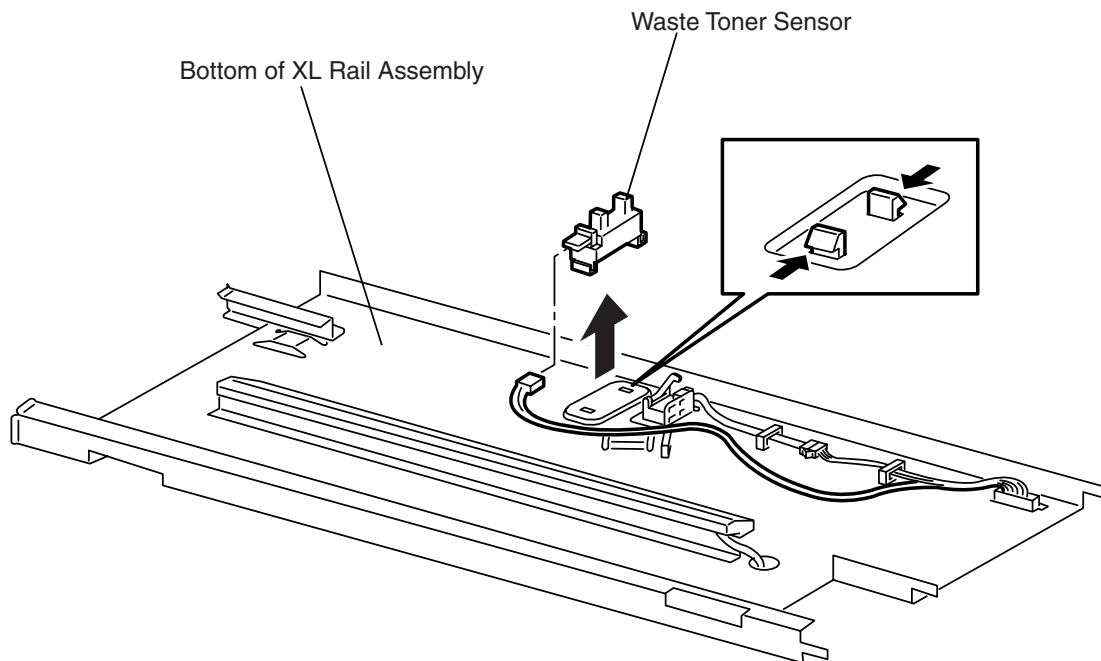
RRP 9.53 Waste Toner Sensor (PL6.1.42)

1. Position the Waste Toner Sensor on the XL Rail Assembly so the P/J faces the Erase Lamp Assembly.
2. Press the two Sensor latch arms into the cutouts in the XL Rail Assembly.
The Sensor snaps into place.
3. Reinstall the XL Rail Assembly (RRP 9.52).

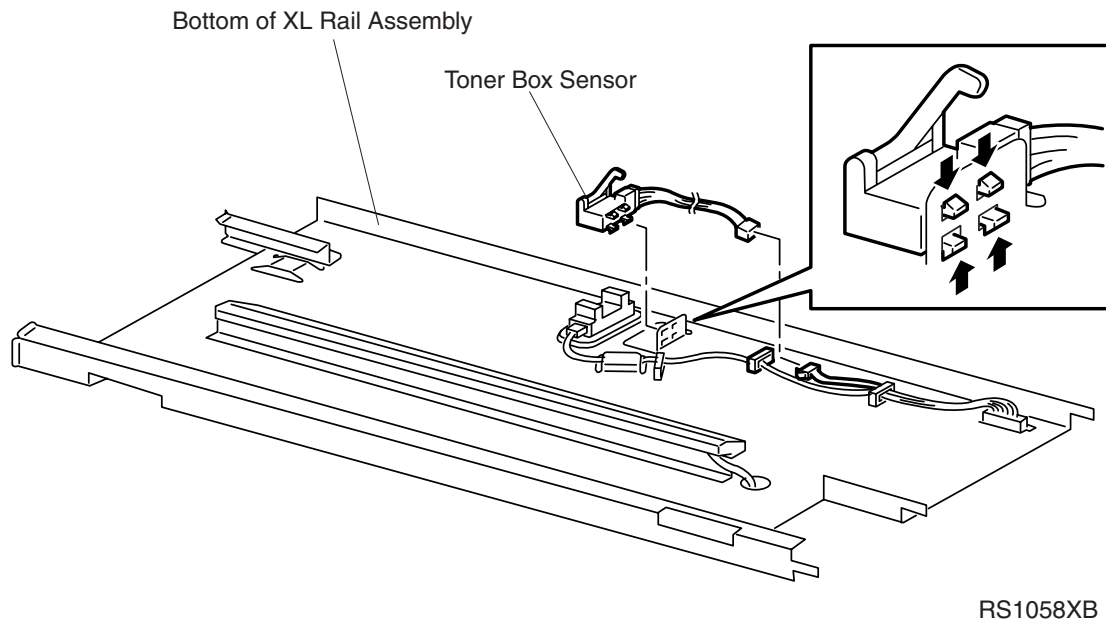
RRP 9.54 Toner Box Sensor (PL6.1.43)

1. Position the Toner Box Sensor on the XL Rail Assembly so the P/J faces away from the Erase Lamp Assembly and the Toner Box Sensor Actuator points up.
2. Press the four Sensor latch arms into the cutouts in the XL Rail Assembly.
The Sensor snaps into place.
3. Reconnect P/J 83 to the Sensor.
4. Reinstall the XL Rail Assembly (RRP 9.52).

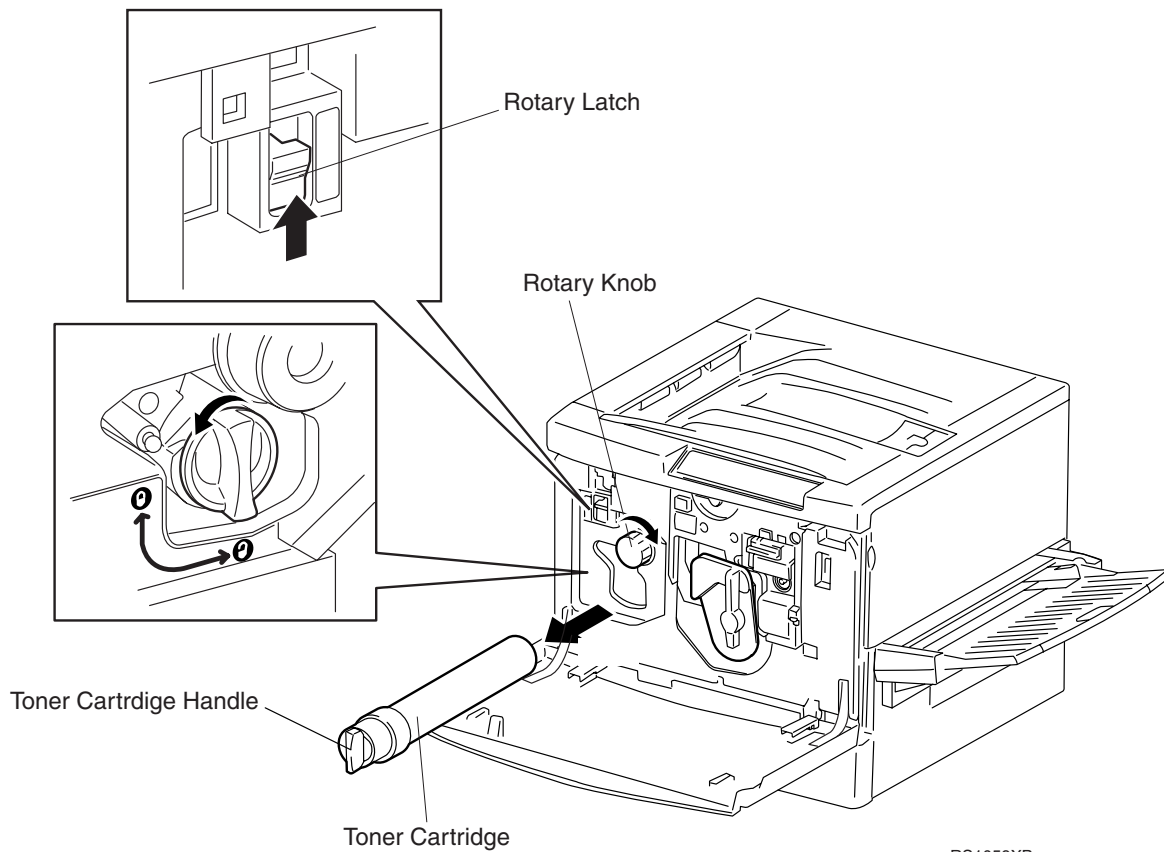
RRP 9.55 Yellow (Y) Toner Cartridge (PL7.1.1)

1. If you are replacing an old Yellow Toner Cartridge with a new one, prepare the new Cartridge according to the instructions presented in the Renoir User Manual.
2. Open the Front Cover.
3. Push up and hold the Rotary Latch Lever that is located above and to the left of the Rotary Knob.
4. Turn the Rotary Knob in the direction of the arrows printed on the Knob.
5. Stop turning the Knob when the Yellow Developer Housing is lined up within the cutout just below the Rotary Knob.
The end of the Yellow Developer Housing is yellow.
6. Release the Rotary Latch Lever.
7. Position the Yellow Toner Cartridge so the printed arrow is on the top of the Cartridge and is facing the printer.
8. Slide the Cartridge as far as it will go into the printer.
9. Turn the Yellow Toner Cartridge handle clockwise until it stops.
The Yellow Toner Cartridge is now locked in place.
10. Close the Front Cover.

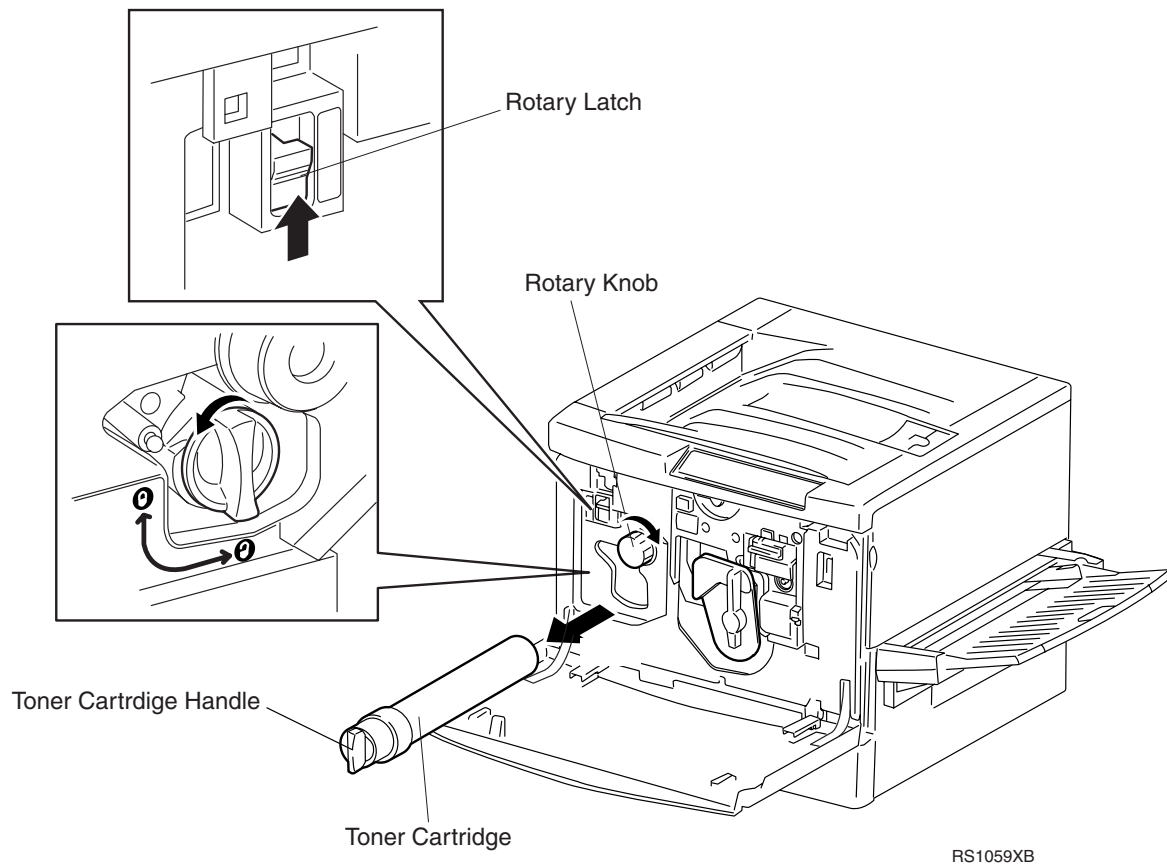
RRP 9.56 Magenta (M) Toner Cartridge (PL7.1.2)

1. If you are replacing an old Magenta Toner Cartridge with a new one, prepare the new Cartridge according to the instructions presented in the Renoir User Manual.
2. Open the Front Cover.
3. Push up and hold the Rotary Latch Lever that is located above and to the left of the Rotary Knob.
4. Turn the Rotary Knob in the direction of the arrows printed on the Knob.
5. Stop turning the Knob when the Magenta Developer Housing is lined up within the cutout just below the Rotary Knob.
The end of the Magenta Developer Housing is magenta.
6. Release the Rotary Latch Lever.
7. Position the Magenta Toner Cartridge so the printed arrow is on the top of the Cartridge and is facing the printer.
8. Slide the Cartridge as far as it will go into the printer.
9. Turn the Magenta Toner Cartridge handle clockwise until it stops.
The Magenta Toner Cartridge is now locked in place.
10. Close the Front Cover.

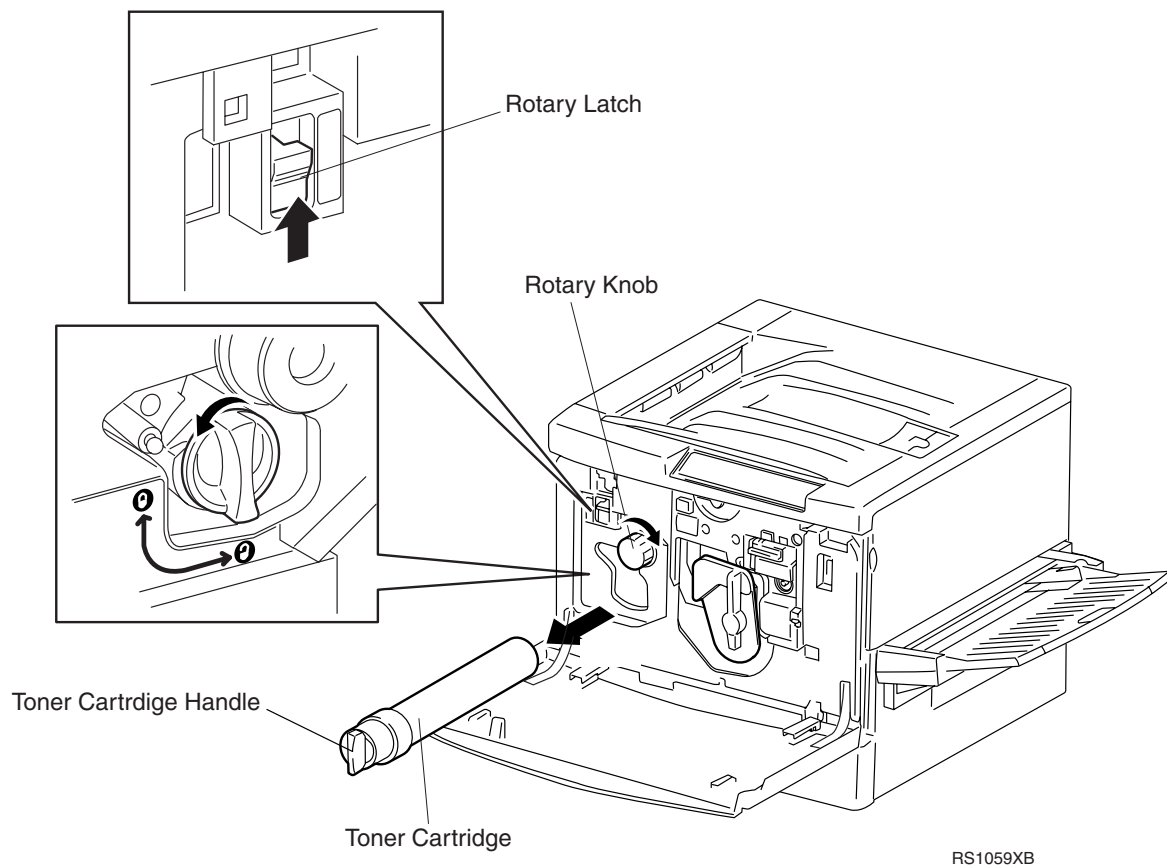
RRP 9.57 Cyan (C) Toner Cartridge (PL7.1.3)

1. If you are replacing an old Cyan Toner Cartridge with a new one, prepare the new Cartridge according to the instructions presented in the Renoir User Manual.
2. Open the Front Cover.
3. Push up and hold the Rotary Latch Lever that is located above and to the left of the Rotary Knob.
4. Turn the Rotary Knob in the direction of the arrows printed on the Knob.
5. Stop turning the Knob when the Cyan Developer Housing is lined up within the cutout just below the Rotary Knob.
The end of the Cyan Developer Housing is cyan.
6. Release the Rotary Latch Lever.
7. Position the Cyan Toner Cartridge so the printed arrow is on the top of the Cartridge and is facing the printer.
8. Slide the Cartridge as far as it will go into the printer.
9. Turn the Cyan Toner Cartridge handle clockwise until it stops.
The Cyan Toner Cartridge is now locked in place.
10. Close the Front Cover.

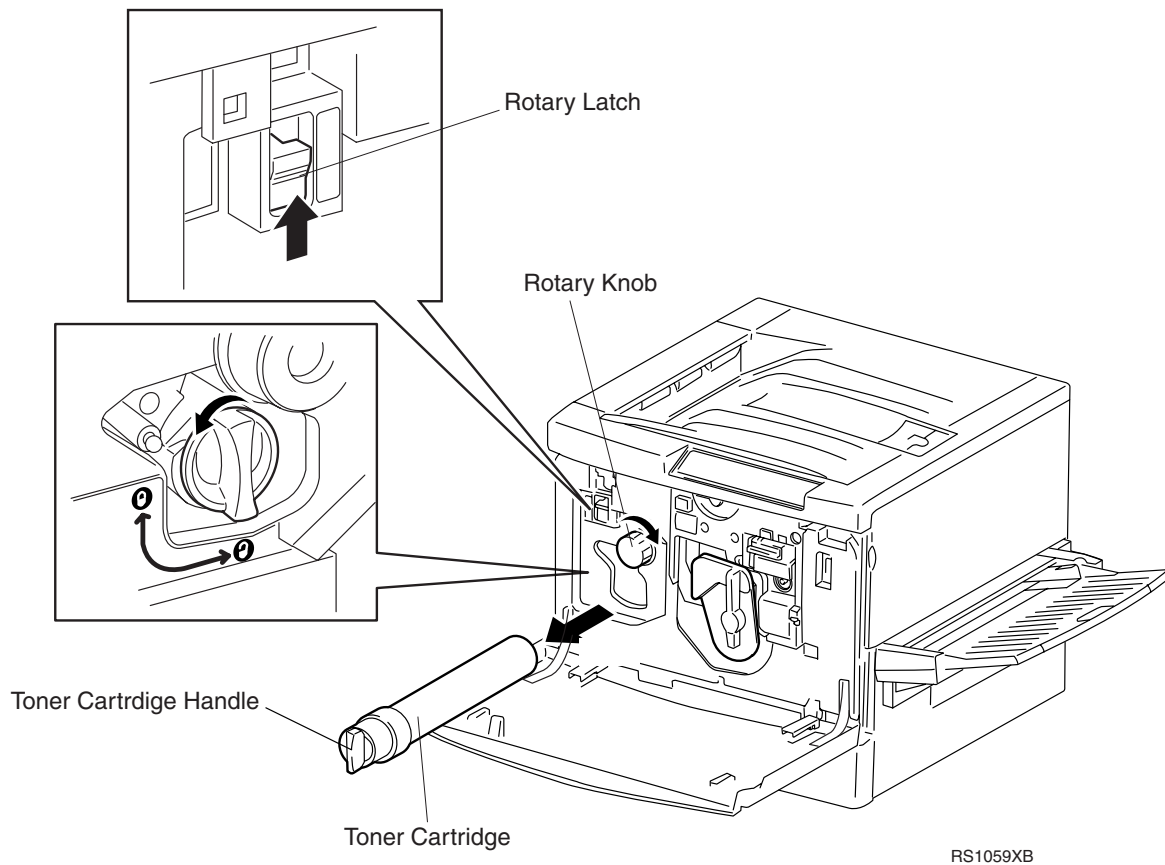
RRP 9.58 Black (K) Toner Cartridge (PL7.1.4)

1. If you are replacing an old Black Toner Cartridge with a new one, prepare the new Cartridge according to the instructions presented in the Renoir User Manual.
2. Open the Front Cover.
3. Push up and hold the Rotary Latch Lever that is located above and to the left of the Rotary Knob.
4. Turn the Rotary Knob in the direction of the arrows printed on the Knob.
5. Stop turning the Knob when the Black Developer Housing is lined up within the cutout just below the Rotary Knob.
The end of the Black Developer Housing is black.
6. Release the Rotary Latch Lever.
7. Position the Black Toner Cartridge so the printed arrow is on the top of the Cartridge and is facing the printer.
8. Slide the Cartridge as far as it will go into the printer.
9. Turn the Black Toner Cartridge handle clockwise until it stops.
The Black Toner Cartridge is now locked in place.
10. Close the Front Cover.

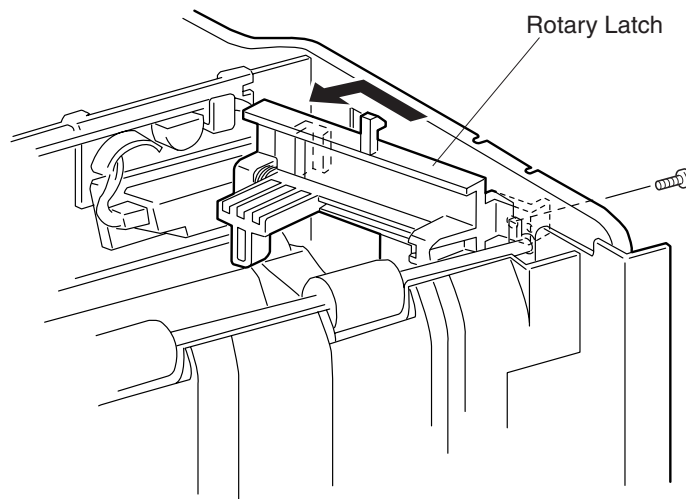
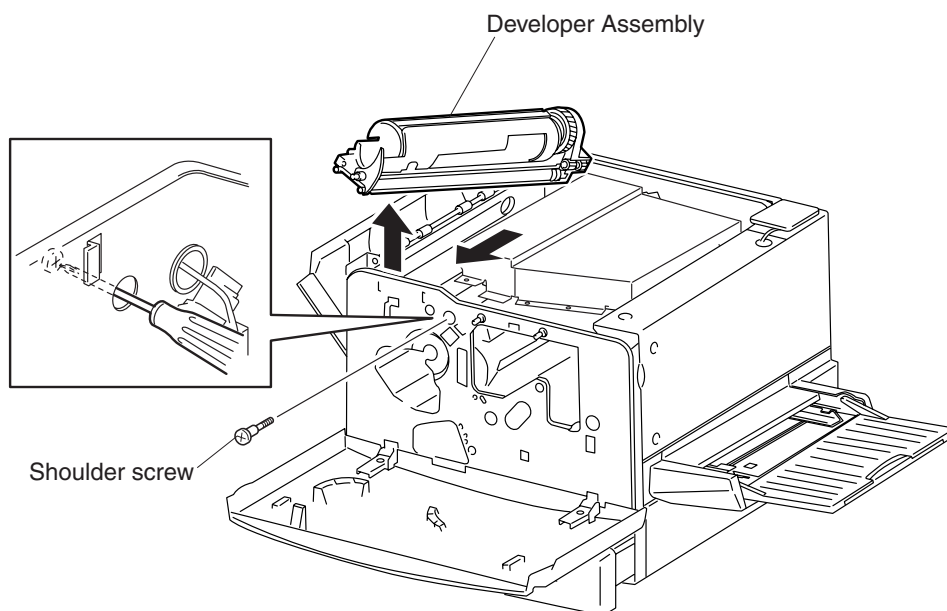
RRP 9.59 Yellow (Y) Developer Assembly (PL7.1.10)

11. Make sure you do not damage the Exit Actuator as you lift the front of the Yellow Developer Assembly to free the front of the Assembly from the front of the printer frame, and remove the Assembly.

4. Lower the front end of the Assembly making sure you do not damage the Exit Actuator.
5. Reposition the Yellow Developer Assembly until the Assembly seats firmly in the Rotary Frame and the screw hole at the front of the Assembly lines up with the screw hole at the front of the Rotary Frame.

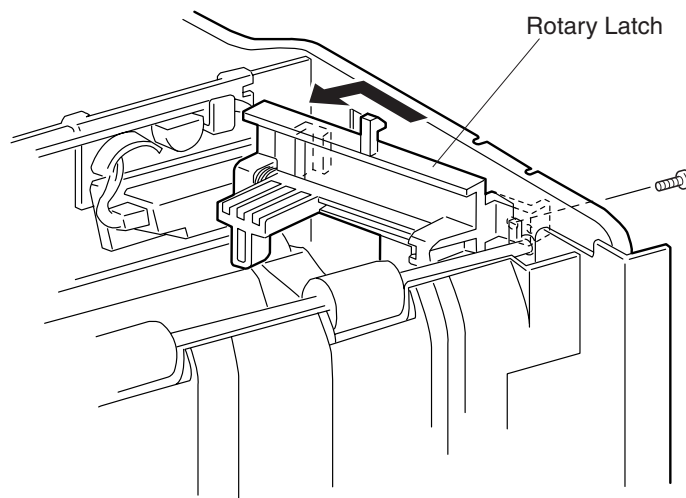
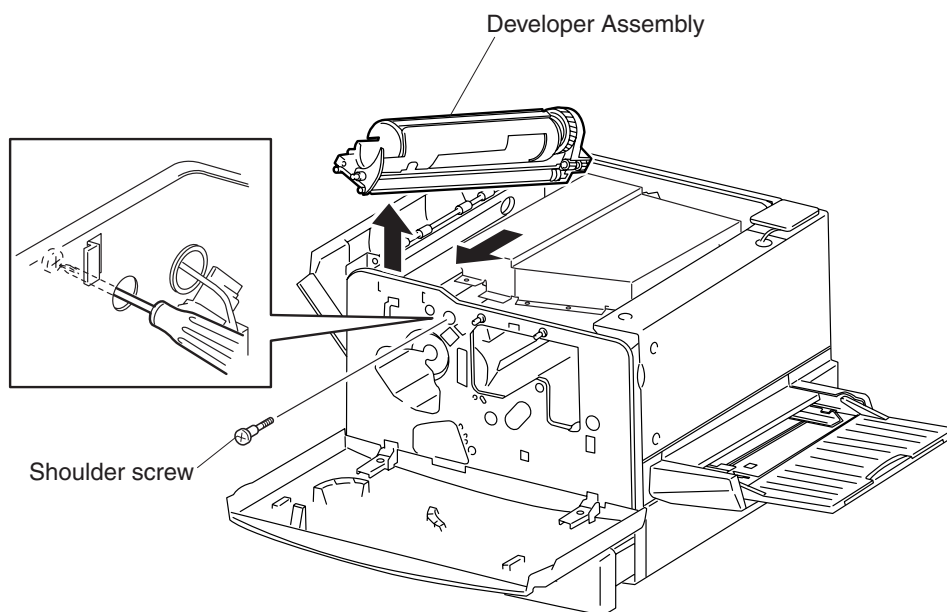
RRP 9.61 Magenta (M) Developer Assembly (PL7.1.20)

11. Make sure you do not damage the Exit Actuator as you lift the front of the Magenta Developer Assembly to free the front of the Assembly from the front of the printer frame, and remove the Assembly.

4. Lower the front end of the Assembly making sure you do not damage the Exit Actuator.
5. Reposition the Magenta Developer Assembly until the Assembly seats firmly in the Rotary Frame and the screw hole at the front of the Assembly lines up with the screw hole at the front of the Rotary Frame.

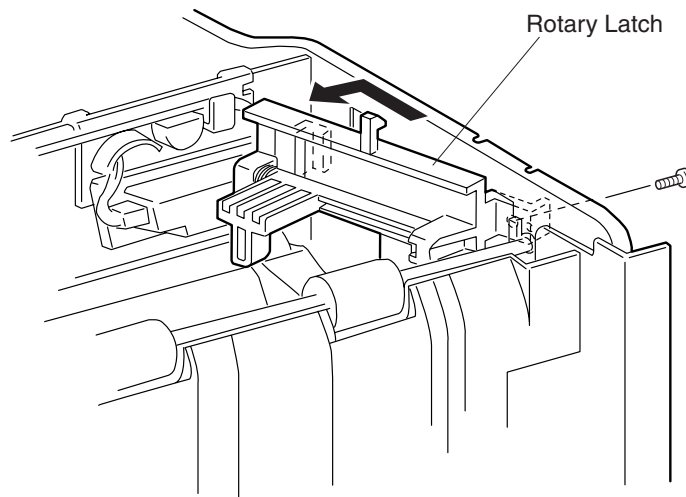
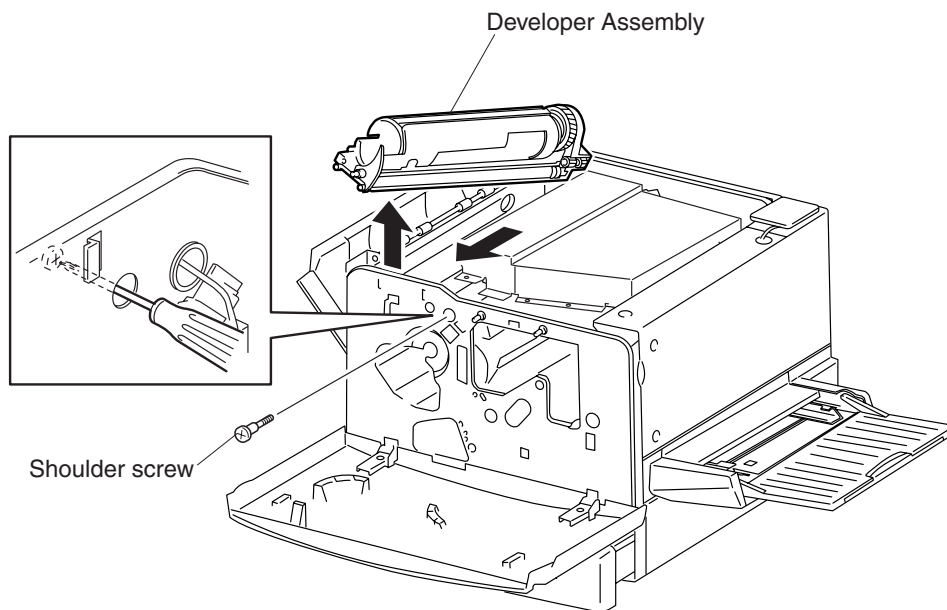
RRP 9.63 Cyan (C) Developer Assembly (PL7.1.30)

11. Make sure you do not damage the Exit Actuator as you lift the front of the Cyan Developer Assembly to free the front of the Assembly from the front of the printer frame, and remove the Assembly.

4. Lower the front end of the Assembly making sure you do not damage the Exit Actuator.
5. Reposition the Cyan Developer Assembly until the Assembly seats firmly in the Rotary Frame and the screw hole at the front of the Assembly lines up with the screw hole at the front of the Rotary Frame.

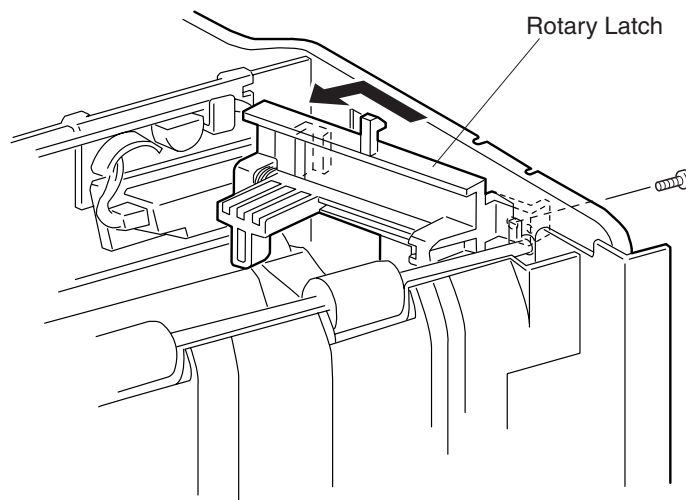
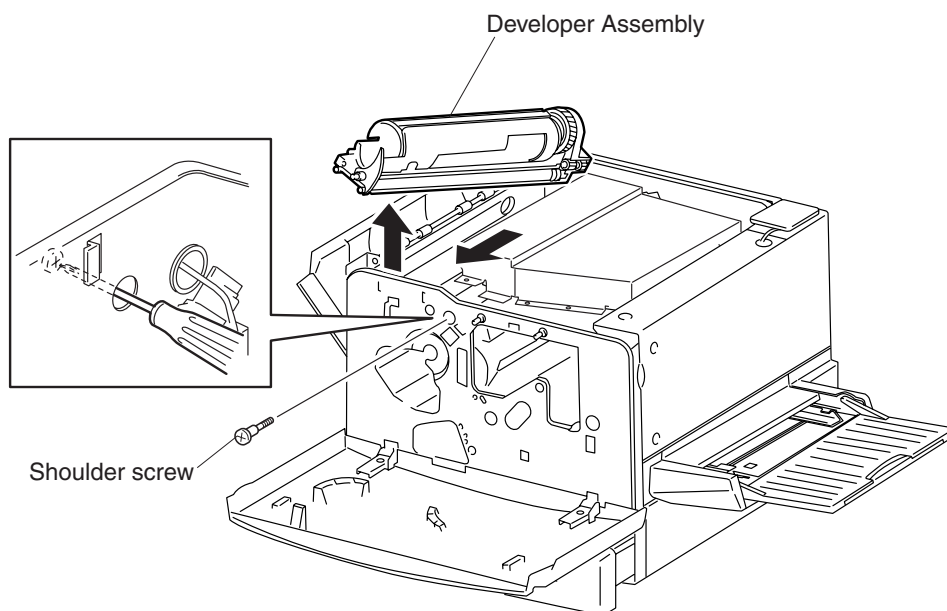
RRP 9.65 Black (K) Developer Assembly (PL7.1.40)

11. Make sure you do not damage the Exit Actuator as you lift the front of the Black Developer Assembly to free the front of the Assembly from the front of the printer frame, and remove the Assembly.

4. Lower the front end of the Assembly making sure you do not damage the Exit Actuator.
5. Reposition the Black Developer Assembly until the Assembly seats firmly in the Rotary Frame and the screw hole at the front of the Assembly lines up with the screw hole at the front of the Rotary Frame.

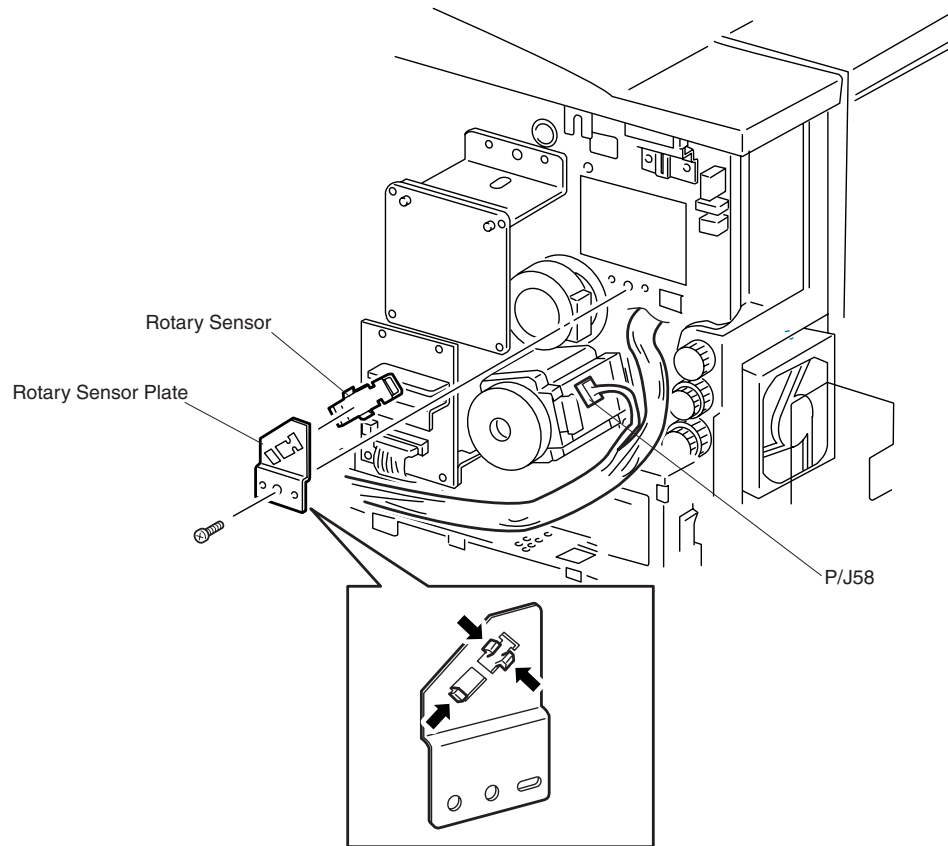
RS1063XB

RRP 9.68 Rotary Sensor (PL7.2.22)

1. Position the Rotary Sensor against the Rotary Sensor Plate.
2. Press the Sensor latches into the cutout in the Plate.
The Sensor snaps into place.
3. Reconnect P/J 58 to the Rotary Sensor.
4. Position the Rotary Plate against the printer frame so the Rotary Sensor is facing into the cutout in the frame.
5. Realign the Plate so the screw hole and two positioning holes in the Plate line up with the screw hole and two positioning pins on the printer frame.
6. Use one screw to secure the Rotary Sensor Plate to the printer frame.
7. Reinstall the duct for the Developer Fan and use one screw to secure the duct to the printer frame.
8. Reinstall the Developer Fan (RRP 9.122).

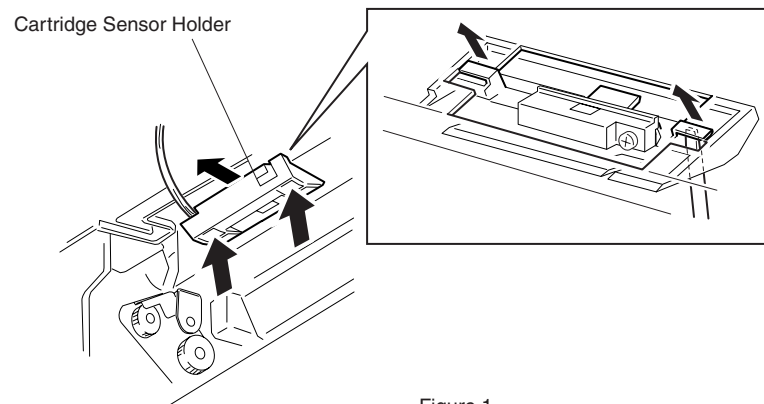
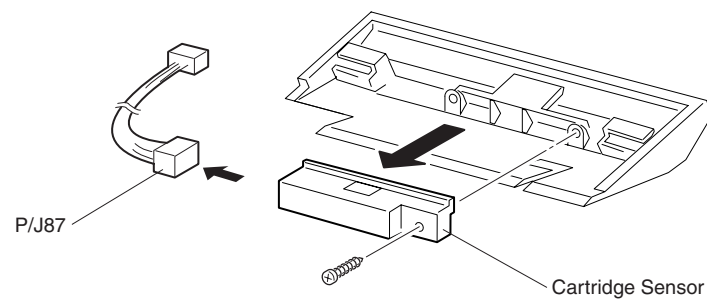
RS1064XB

RRP 9.69 Cartridge Sensor (PL7.2.26)

1. Position the Cartridge Sensor onto the Sensor Holder so the LEDs face out.
2. Line up the position tab and screw hole on the Sensor with the two holes in the Holder.
3. Use one screw to secure the Cartridge Sensor to the Sensor Holder.
4. Reconnect P/J 87 to the Cartridge Sensor.
5. Position the Holder against the Holder cutout in the printer frame.
6. Move the Sensor wire harness so it exit through the cutout at the rear of the Holder.
7. Move the Holder around until the side latches on the Holder line up with the cutouts in the frame.
8. Push the Holder forward until the front latch secures the Holder to the frame.
9. Reinstall the Fuser Assembly (RRP 9.80).

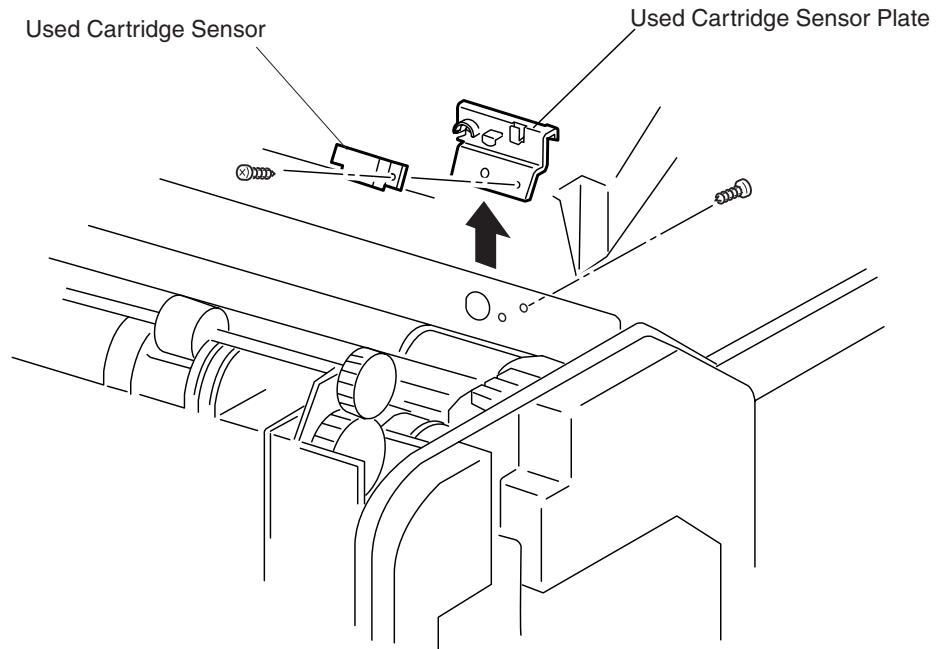
RS1065XB

RRP 9.70 Used Cartridge Sensor (PL7.2.30)

1. Position the Used Cartridge Sensor on the Sensor Plate so the screw holes line up.
2. Use one screw to secure the Sensor to the Plate.
3. Reconnect P/J 88 to the Used Cartridge Sensor.
4. Reinstall the Used Cartridge Sensor Plate to the printer frame and use one screw to secure the Plate.
5. Reinstall the Top Cover (RRP 9.3).

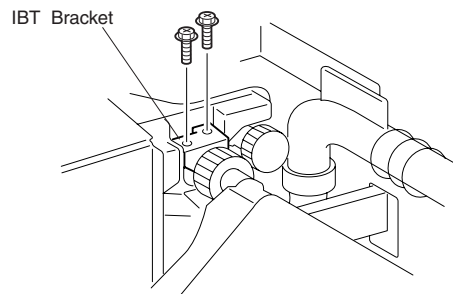
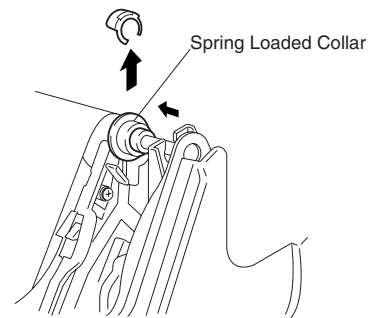
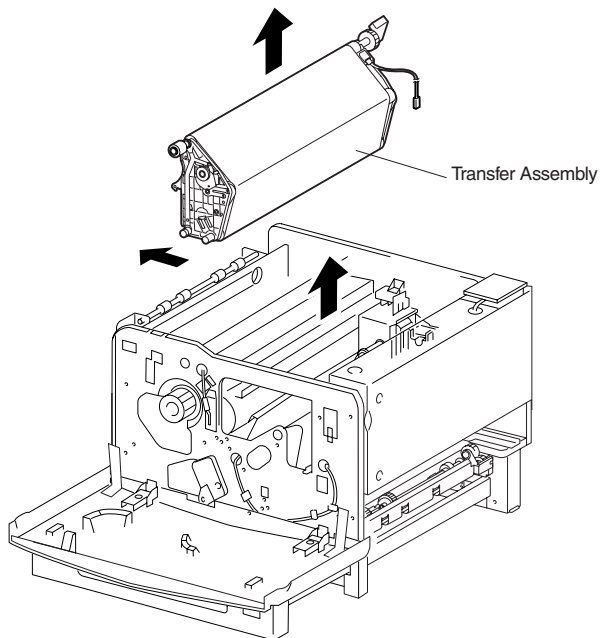
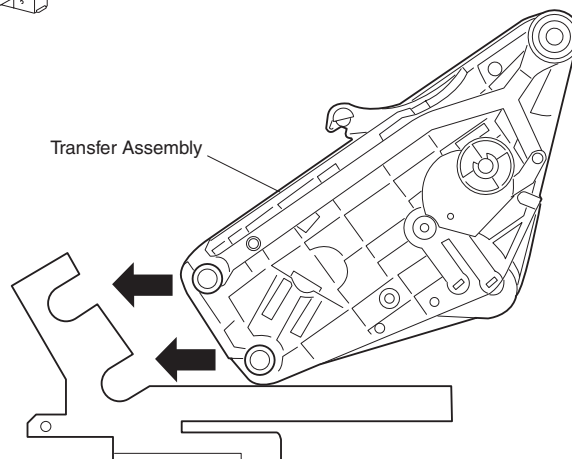
RS1066XB

RRP 9.71 Transfer Assembly (PL8.1.3)

1. Hold on to the front and the rear of the IBT shaft.
2. Position the Transfer Assembly so the TR0 Sensor is at the rear of the printer.
3. Carefully lower the back of the Transfer Assembly into the printer frame, making sure the plastic rollers at the back of Assembly fit into place in the grooves in the printer frame (Figure 4).

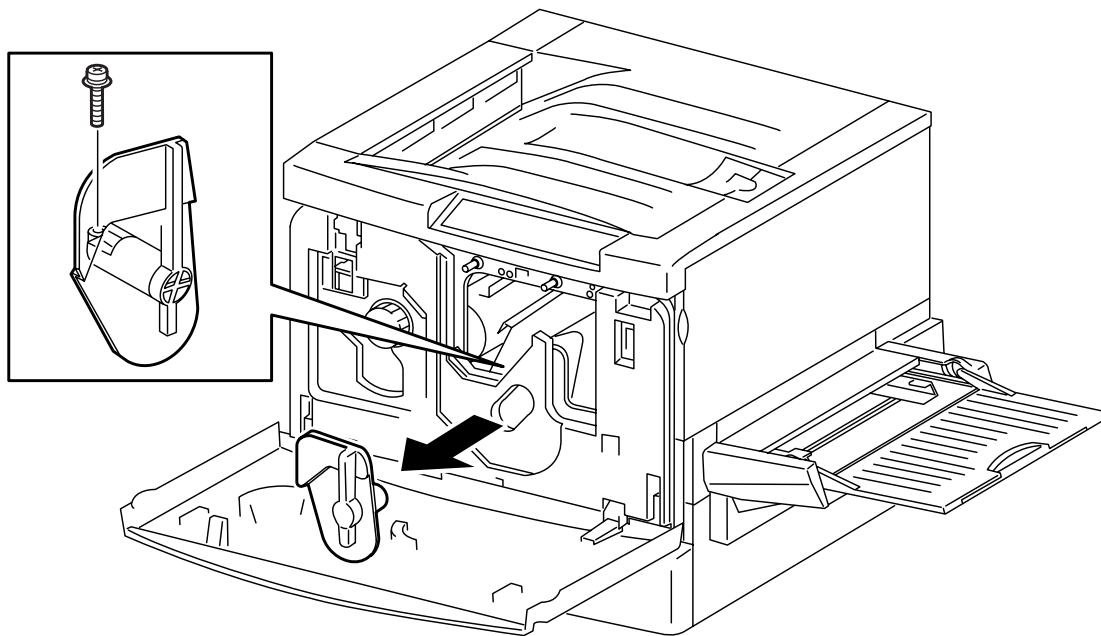
RS1067XB

RRP 9.72 Tension Lever (PL8.1.4)

1. Remove the Xerographic Cartridge (RRP 9.48).
2. Rotate the Tension Lever clockwise.
3. Loosen the screw securing the Tension Lever to the IBT Push In Shaft.
4. Slide the Tension Lever off of the Shaft.

1. Rotate the Tension Lever slightly to find the flat spot on the IBT Push In Shaft, then push the Lever as far as it will go onto the Shaft.
2. Tighten the screw securing the Tension Lever to the IBT Push In Shaft.
3. Rotate the Tension Lever counter clockwise and clockwise to make sure the Lever is securely in place on the Shaft.
4. Reinstall the Xerographic Cartridge (RRP 9.48).

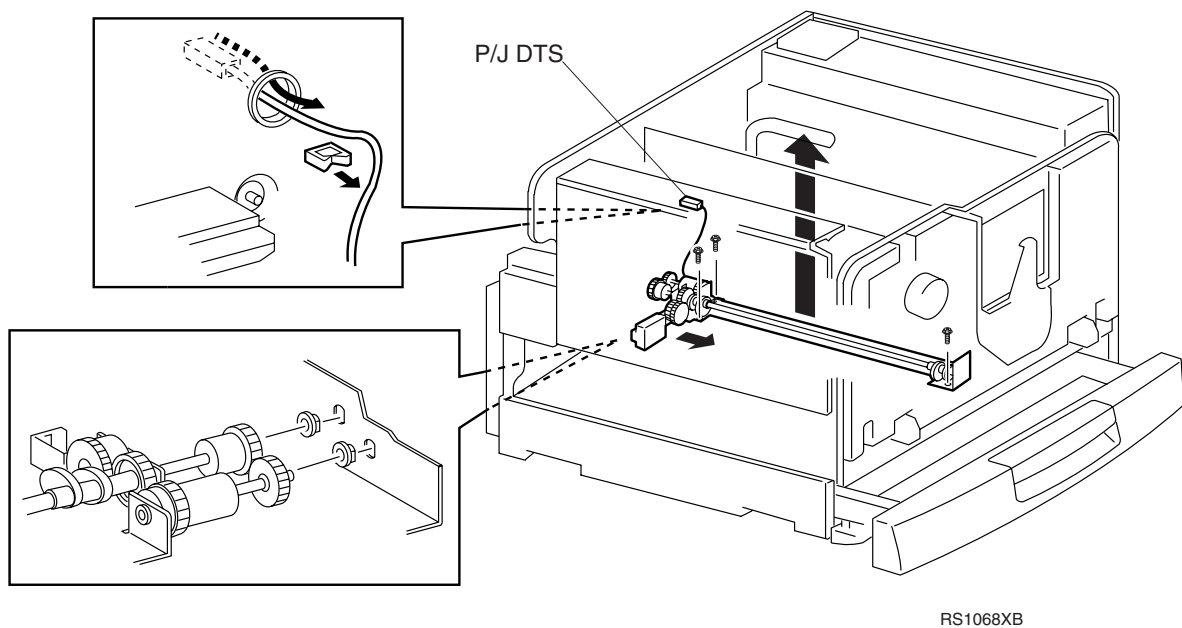
RS1068XB

RRP 9.73 2nd BTR Cam Assembly (PL8.1.10)

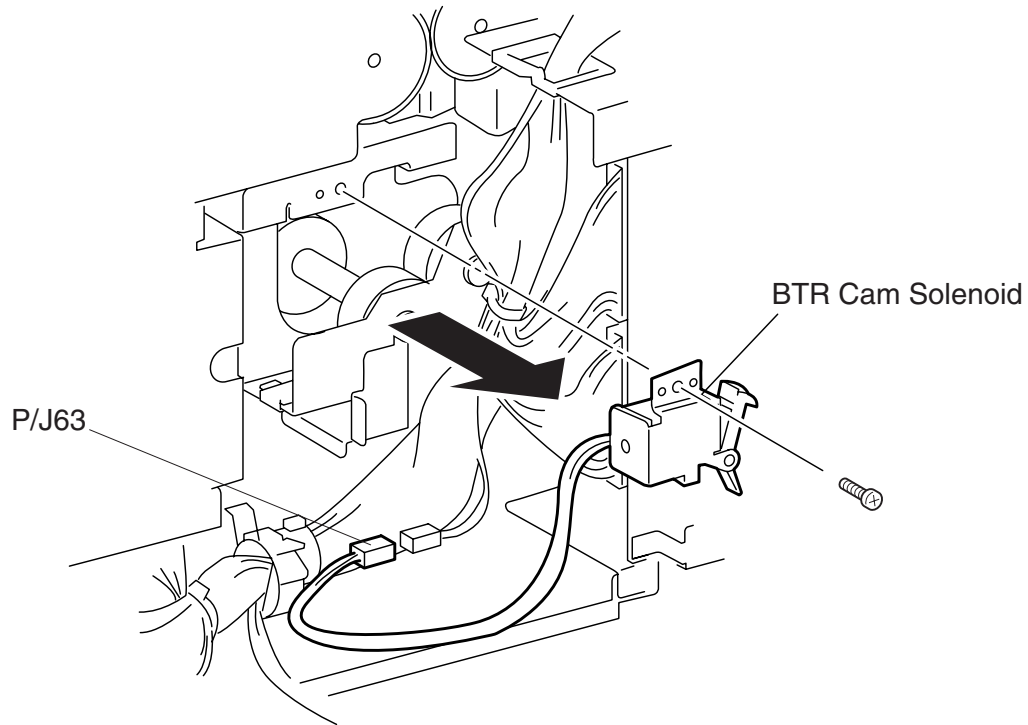
RS1069XB

RRP 9.74 BTR Cam Solenoid (PL8.1.15)

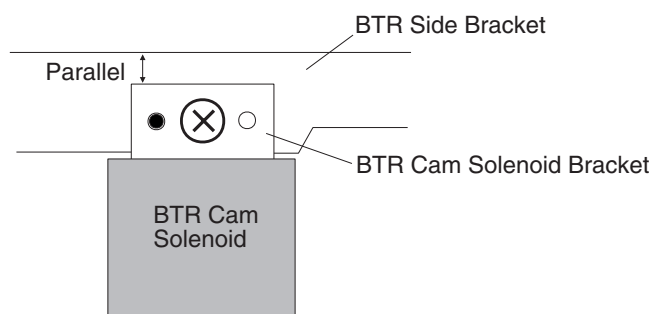
RS2027X

Make sure the top edge of the BTR Cam Solenoid Bracket is mounted parallel with the top edge of the BTR Side Bracket. Image quality problems may result if the Solenoid Bracket is not parallel.

3. Use one screw to secure the BTR Cam Solenoid to the BTR Side Bracket.
4. Reconnect P/J 63 to the BTR Cam Solenoid.
5. Reinstall the High Voltage Power Supply (RRP 9.120).

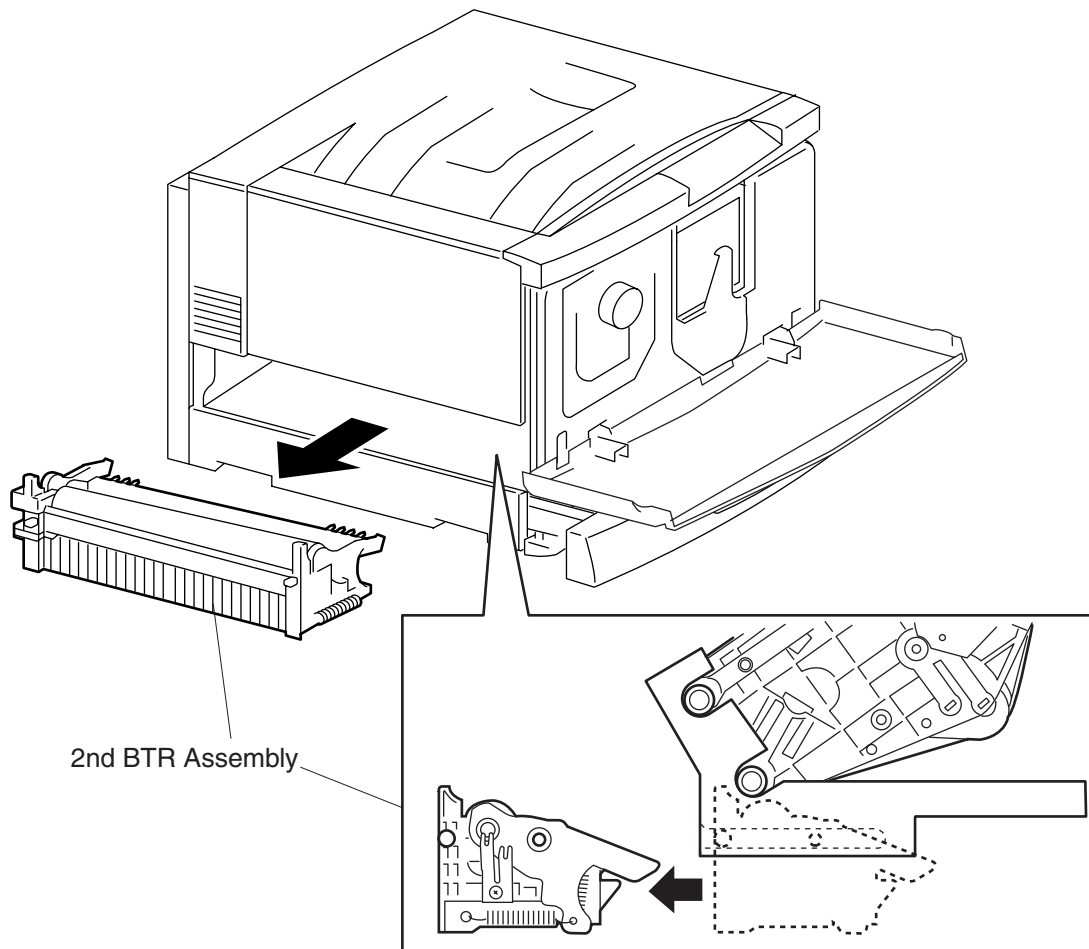
RS1070XB

RRP 9.75 2nd BTR Assembly (PL8.1.20)

1. Position the 2nd BTR so the gears face the rear of the printer and place the 2nd BTR Assembly on the frame inside the empty Fuser cavity.
2. Place your left hand on the rear of the 2nd BTR and place your right hand on the front of the 2nd BTR and push the 2nd BTR into the slots in the IBT Front and Rear Brackets.
3. Push hard on both ends to make sure the 2nd BTR has seated correctly.
4. Reinstall the Belt Cleaner Assembly (RRP 9.76).
5. Reinstall the Transfer Assembly (RRP 9.71).
6. Refer to Section 9 of this manual and reset the 2nd BTR Assembly Life Counter to zero.
